**ASECAP DAYS**

**MILANO 2024**

# Road maintenance and security with satellite-based displacement analysis

**SATELLITE SLOPE MONITORING**

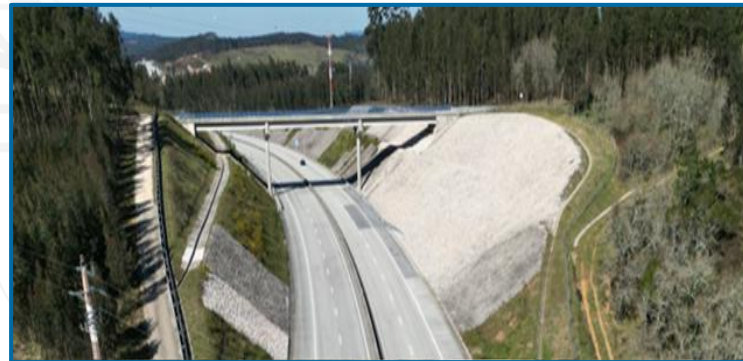
### 2. NORTH EXCAVATION SLOPE (PK: 181+095/810)

- Repair work conducted between 2016 and 2018.
- Landslides in December 2019.
- Intervention completed in 2021

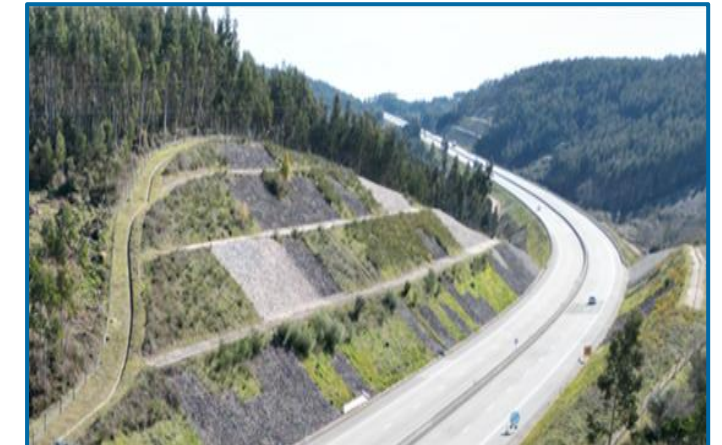
### 3. SOUTH EXCAVATION SLOPE (PK: 180+400/730)

- Intervention on the first slope bench in August 2018.

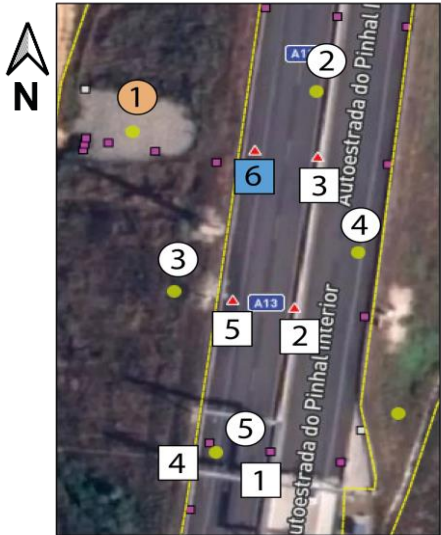
# 04. Results – Embankment Slope (PK: 180+715/181+95)

- Satellite Points
- Topographic Targets

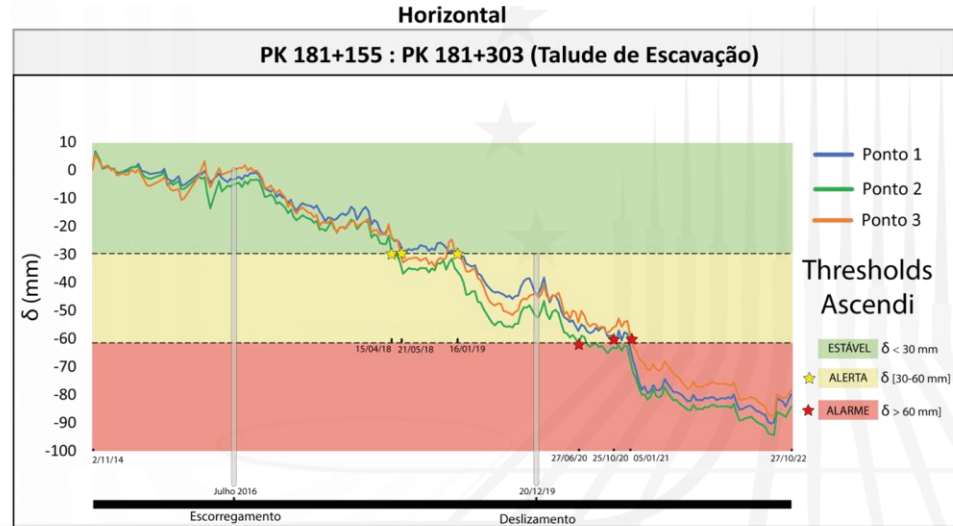
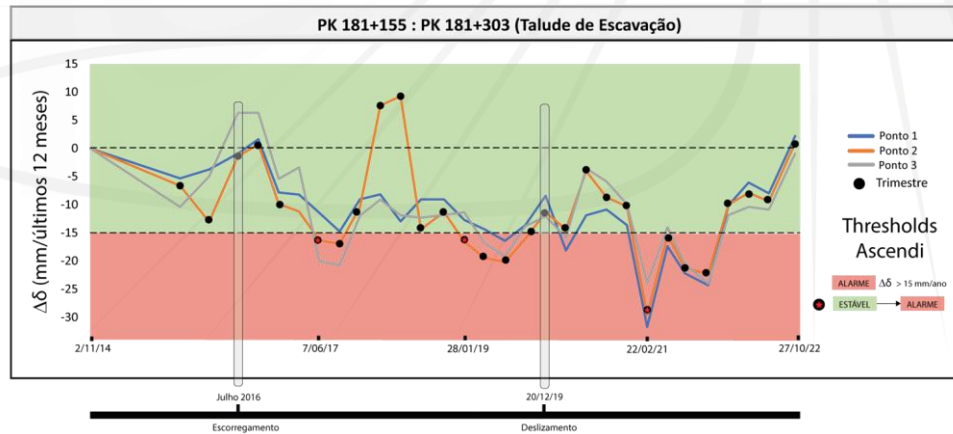
## Observed Horizontal Displacements - InSAR

## Cumulative Displacement

- Alarms went off from 2020 (displacement  $> 60$  mm), with earlier alerts noted in 2018.
- After the intervention in 2021, the slope showed a stable behavior in 2022.

## Deformation Rate (Quarterly)

- The stabilisation work from 2016 to 2018 does not appear to have been fully effective.
- The highest displacements were observed in 2020 and 2021.

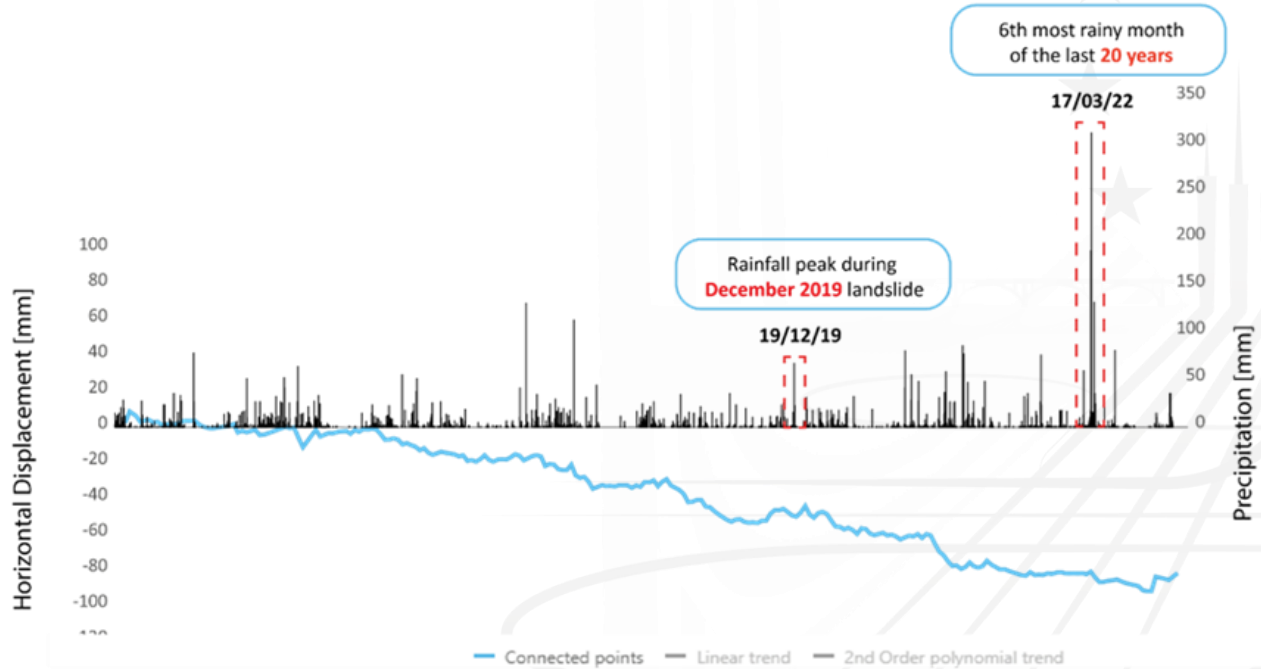
## Weather Data versus InSAR Data

- Utilizing satellite rainfall data with a 4 km spatial resolution enhances the InSAR analysis.
- By combining cumulative displacement data with daily precipitation records, we identified a significant rainfall peak in December 2019, coinciding with landslide.

- ❖ Identified stable and unstable areas on embankment and excavation slopes, capturing the main instability scenarios.
- ❖ Similar movement trends comparing with topographic targets
  - with variations in displacement amplitudes
- ❖ Integration with Precipitation Data enhances its potential as an Early Warning tool
  - improving understanding of the relationships between displacement, rainfall, and landslide.
