A comprehensive maintenance plan for **infrastructure** at Nea Odos

Asterios Simopoulos

Head of Construction Nea & Kentriki Odos

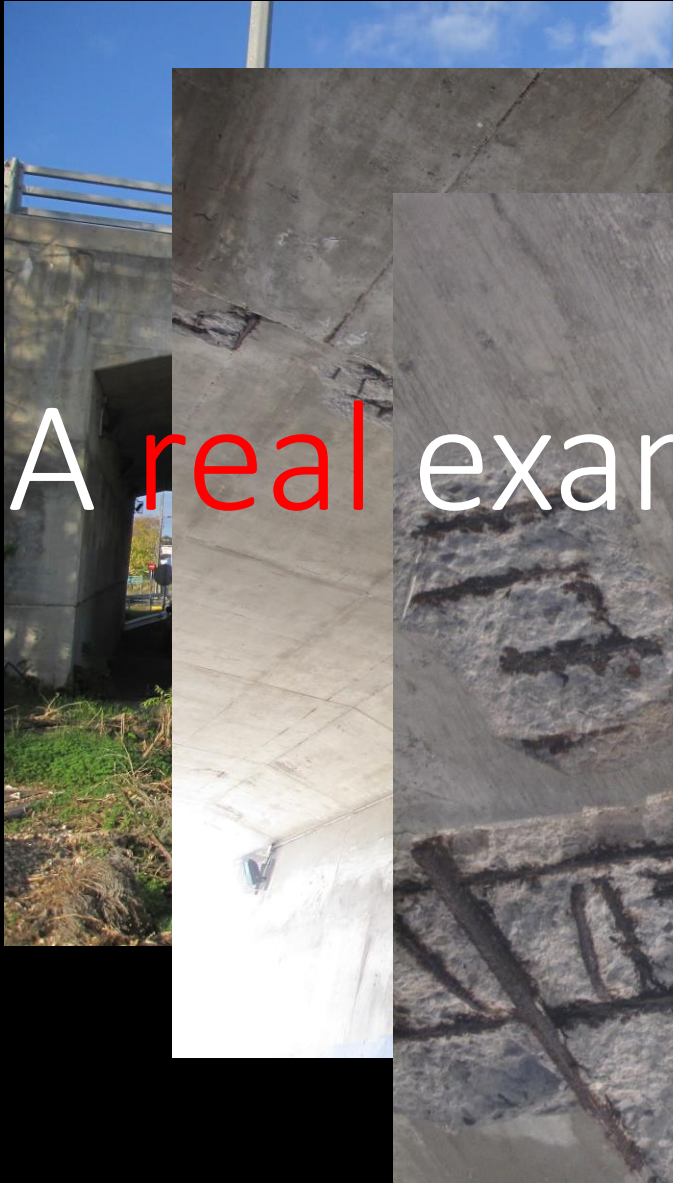
Assessment > Database

KentrikiOdos Bridge Management System

Structure: 70 (ΚΔ01.22.23) Date Of Inspection: 14/11/2016 Inspection ID: 125

Findings I	Group	Rating	Defect	Elem
866	Decks and Slabs	Fair -2-	Cracking (RC and Other) (1130)	Reinforced
867	Decks and Slabs	Good -1-	Exposed Rebar(1090)	Reinforced
868	Decks and Slabs	Fair -2-	Delamination/Spall/ Patched Area (1080)	Reinforced
869	Decks and Slabs	Poor -3-	Exposed Rebar(1090)	Reinforced
870	Decks and Slabs	Good -1-	Efflorescence/Rust Staining(1120)	Reinforced
871	Decks and Slabs	Fair -2-	Efflorescence/Rust Staining(1120)	Reinforced
873	Substructure	Fair -2-	Cracking (RC and Other) (1130)	Abutment

Sufficiency Rating	88,00
Calculation S1	45
Calculation S2	30
Calculation S3	13,00
Calculation S4	0,00
